North Fork Payette River Watershed Agricultural TMDL Implementation Plan

Prepared by

**Kalissa Copeland
Idaho Association of Soil Conservation Districts**

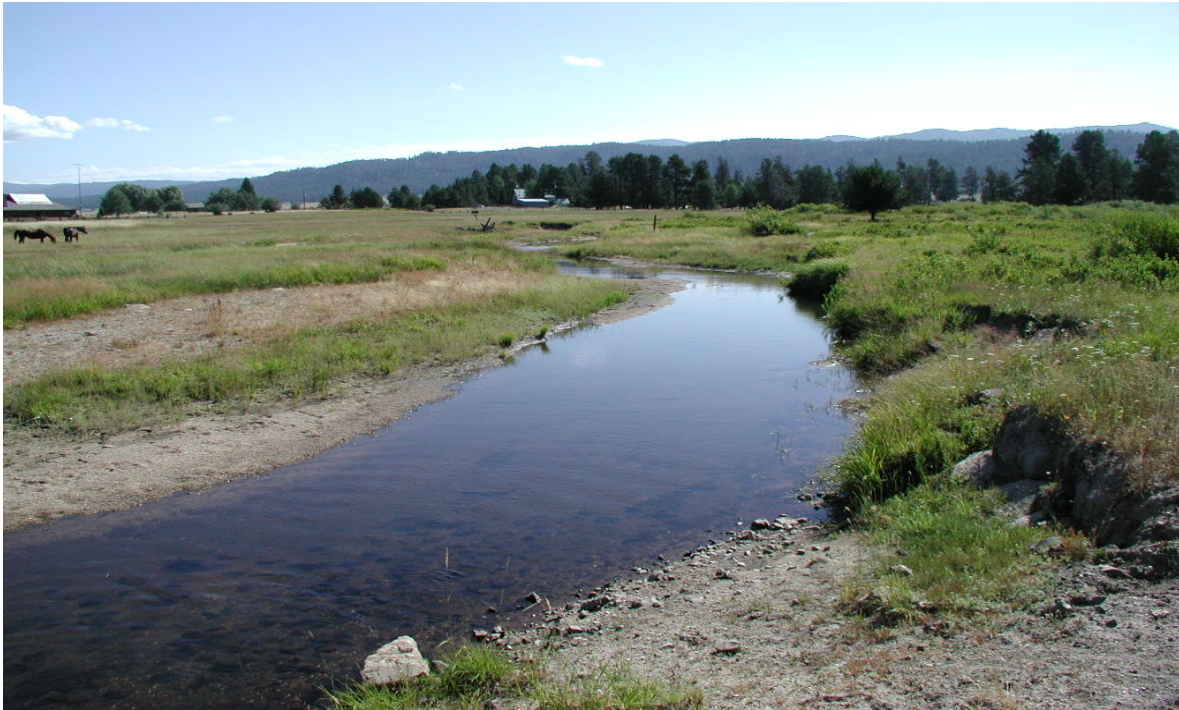
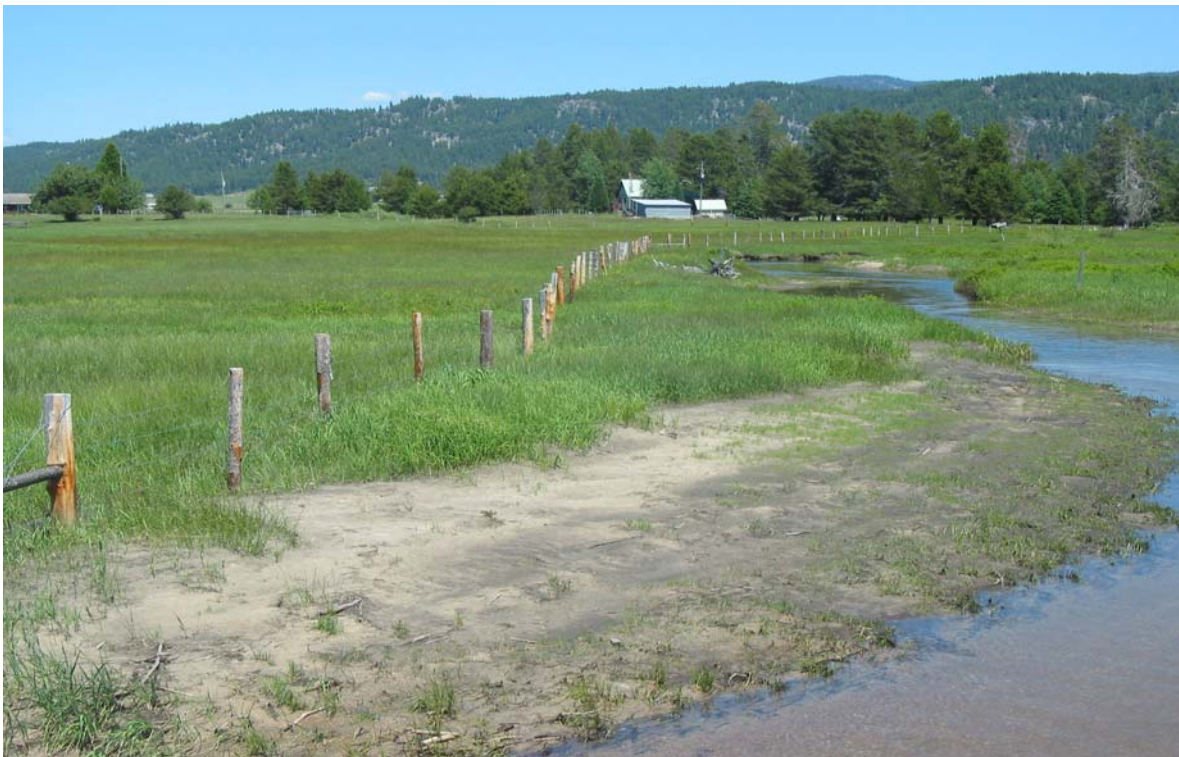
Figure 16. 2004 Clear Creek Fencing Project

Figure 17. 2006 Clear Creek Fencing Project

Beaver Creek, Clear Creek, and Round Valley were assessed by ISCC and IASCD in 2004. Other accomplishments include a field observation assessment of the listed subwatershed reaches conducted by IASCD staff in June 2006. Digital photos were taken in 2006 to see the changes in vegetation since the 2004 assessment. Below are some examples of before and after pictures that were taken. Fencing in the Clear Creek Area showed signs of improvement by 2006. The digital photos are shown below for each creek.
